Restoring Bexhill's Seafront Bandstand

Bexhill Heritage's proposals and recommendations

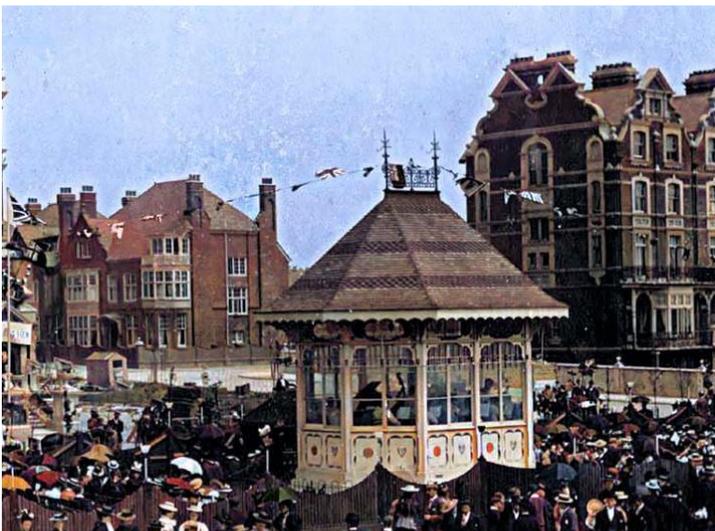
Popular and proud – the 1895 bandstand, a focal point of Bexhill's eastern promenade

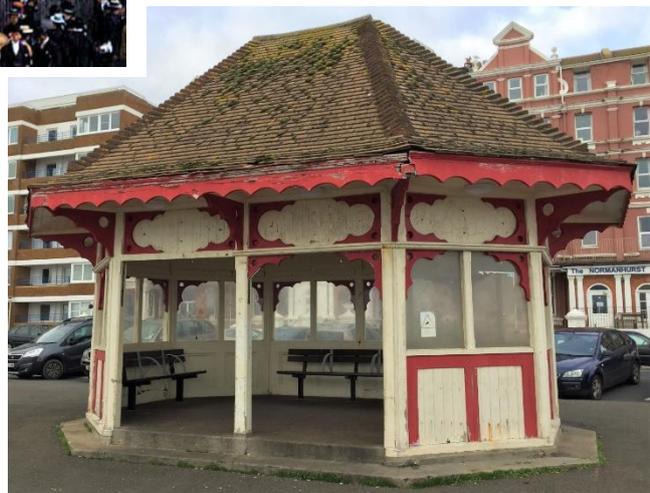
Blot on the landscape – unloved and underused shelter 2020

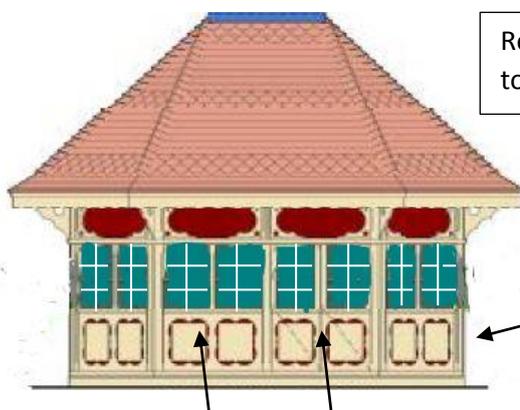
Renovated bandstand – south elevation (north elevation similar but without doors)

Replacement clay tiles including three rows of scallop tiles to match the 1895 bandstand

Colour scheme to match the 1895 bandstand

Lower panels to reference the design of the 1995 bandstand

Two lockable bi-fold doors to open up the south elevation to the promenade

Ground level slightly raised to enable access for all

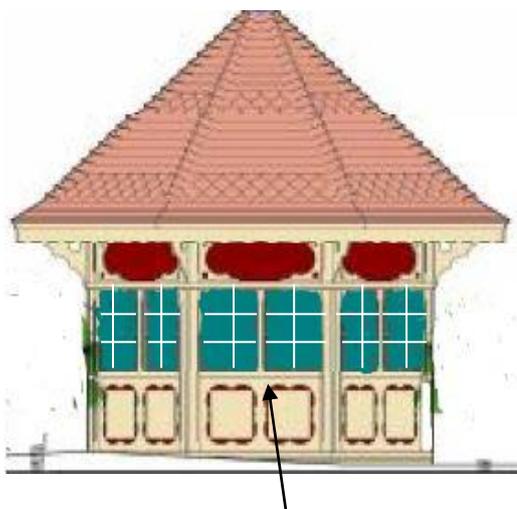
Renovated bandstand – east elevation (West elevation similar but without doors)

One lockable bi-fold door to open up the east elevation to the promenade (to be opened for performances)

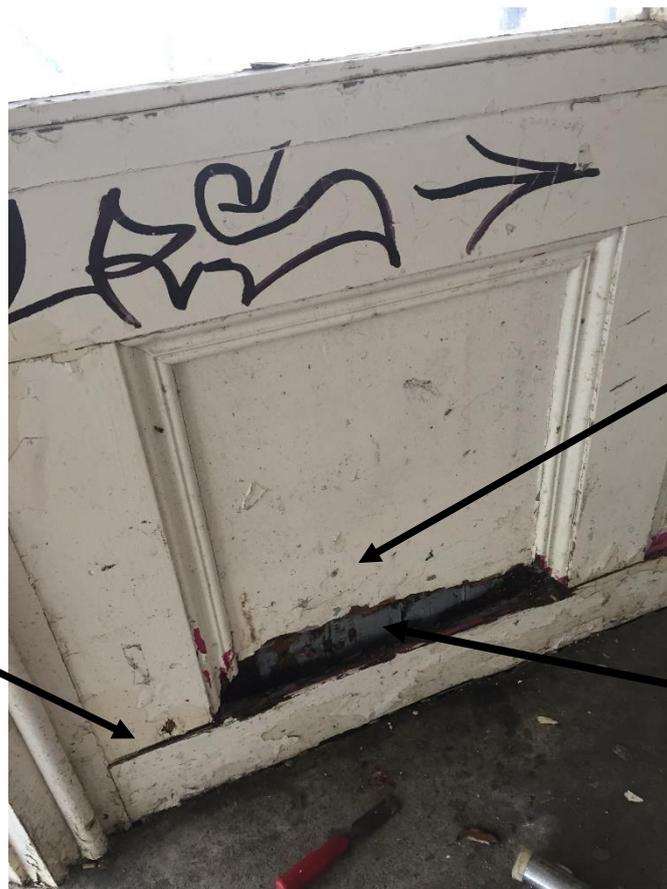
Existing base panels

The base panels were replaced in 2011 following serious vandalism of the building. They have been poorly constructed from unsuitable materials. The lower part of the current 30mm softwood framework shows serious signs of wet rot. The framework has been butt-jointed rather than morticed or pegged. This has resulted in movement and exacerbated water ingress. The inner part of the panels is constructed from interior-grade 12mm plywood. Delamination and wet rot are prevalent. The outer face of the panels is constructed from vertically-aligned tongue and grooved softwood planking. It is likely that these were not caulked on installation. As a result of heat expansion / contraction the boards have divided and twisted. They no longer form a weather-resistant 'skin' to the base of the building.

30mm softwood frame. Butt jointed. No damp proof membrane. Wet rot present.

12mm interior plywood internal face. Poor quality. Delaminating and degrading.

Warped tongue and groove planking exterior face. Wet rot present. Gapping between boards.

We propose that Bexhill Heritage make replacement base panels to match the originals. These would be constructed on a morticed wooden frame built from 30mm timber and protected by a damp proof membrane. The external face would be formed from 18mm marine ply with a decorative 9mm marine ply overlay. The internal face would be 12mm marine ply with the addition of a rectangular decorative moulding to match the existing (Richard Burbidge decorative moulding 44x20mm). The marine ply would be sealed with a two-part epoxy resin primer followed by an undercoat and two coats of 'Toplac' gloss in line with International Paint guide AW044.*

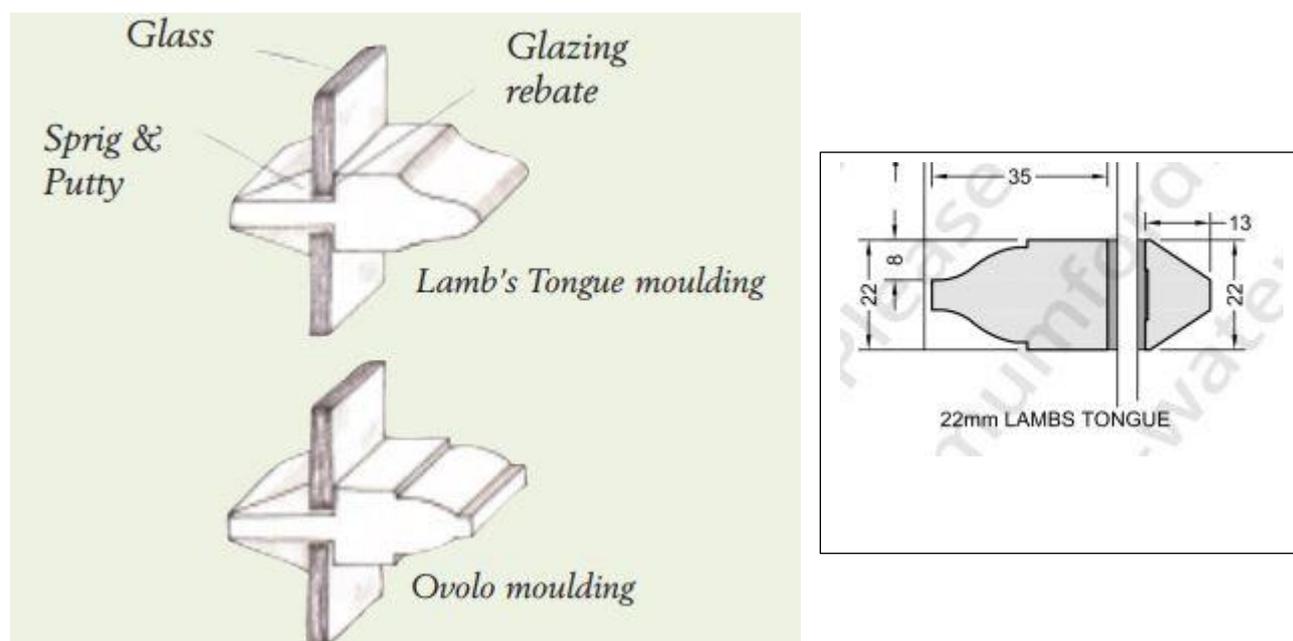
Window glazing bars have been replaced as part of the 2011 restoration. The existing softwood bars are simple and square-edged. They lack the durability required in this location. Square-edged styles

were familiar to the Victorians and were widely used in sash windows for terraced housing. They are insufficiently interesting and decorative for the Victorians to have used them in any prestigious seafront building. Two main decorative styles were used for Georgian, Victorian and Edwardian glazing – Ovolo and Lambs Tongue. Photographic evidence does not show which of these was used in Bexhill’s bandstand. Lambs Tongue incorporates more rounded edges than the other two styles and so paint would more easily adhere to the wooden surfaces. Ovolo matches the bars used in Shelter 3. In order to optimise durability without compromising aesthetics, we would recommend a Lambs Tongue bar 22mm wide and 54mm deep.

We propose that local joinery companies be asked to quote for frames, using 22mm Lambs Tongue glazing bars, to incorporate window panels and cills but not base panels. The latter would be constructed by Bexhill Heritage and fitted to the frames. We propose that a more durable alternative glazing be explored.

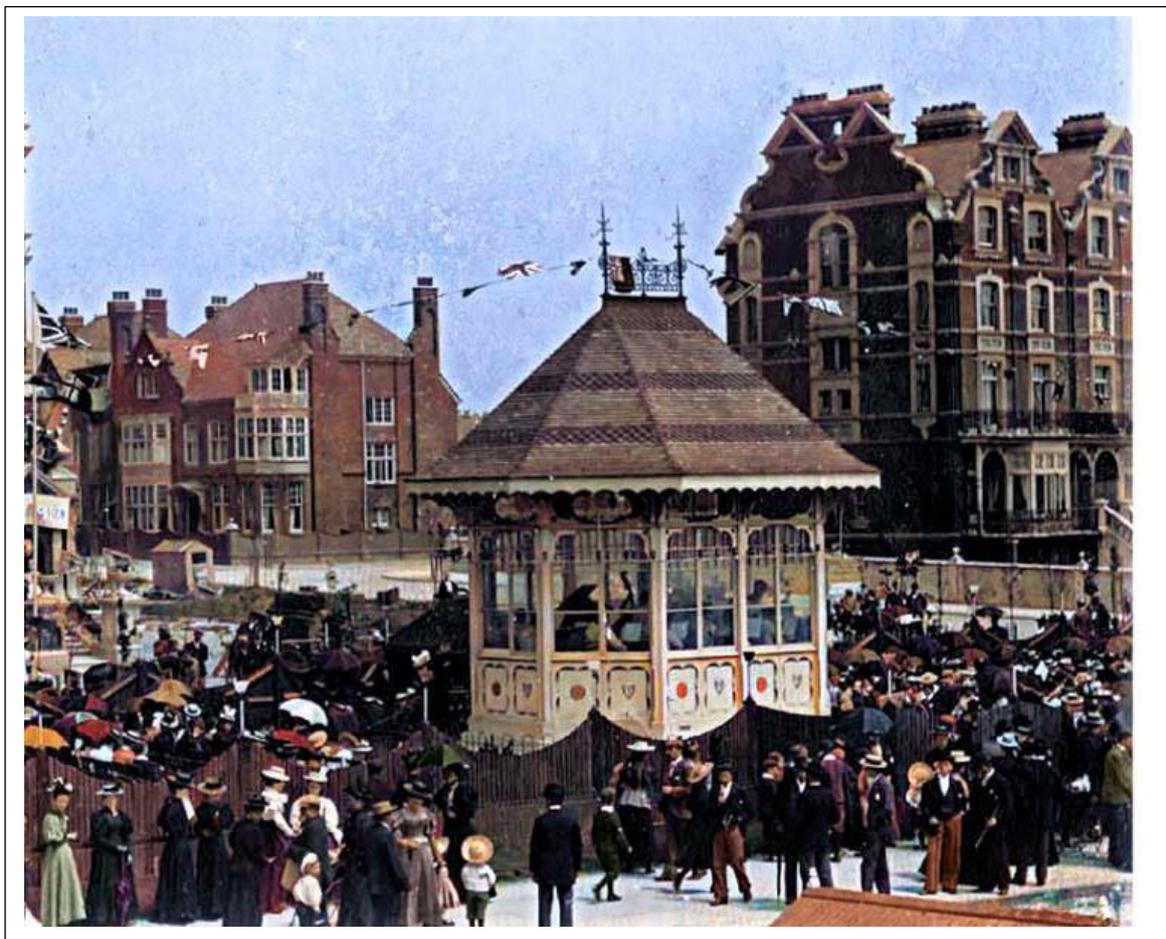
1. Bandstand in 1897. A celebration of Queen Victoria's Jubilee

The bandstand was built by Earl De La Warr in 1895 to provide classical music to people using the promenade. It was the first structure to be built on East Parade and was enclosed by a fence. Seating was provided to the east of the bandstand within the enclosed area (photos 1, 2 and 3). The enclosed area was significantly below the level of the bandstand making it possible for the public to see the conductor and orchestra above (photo 2). Lights on posts were placed at approximately 3 metre intervals around the enclosure (photo 1)

The original bandstand was well proportioned in a ratio of 5:14:9 (photo 1).

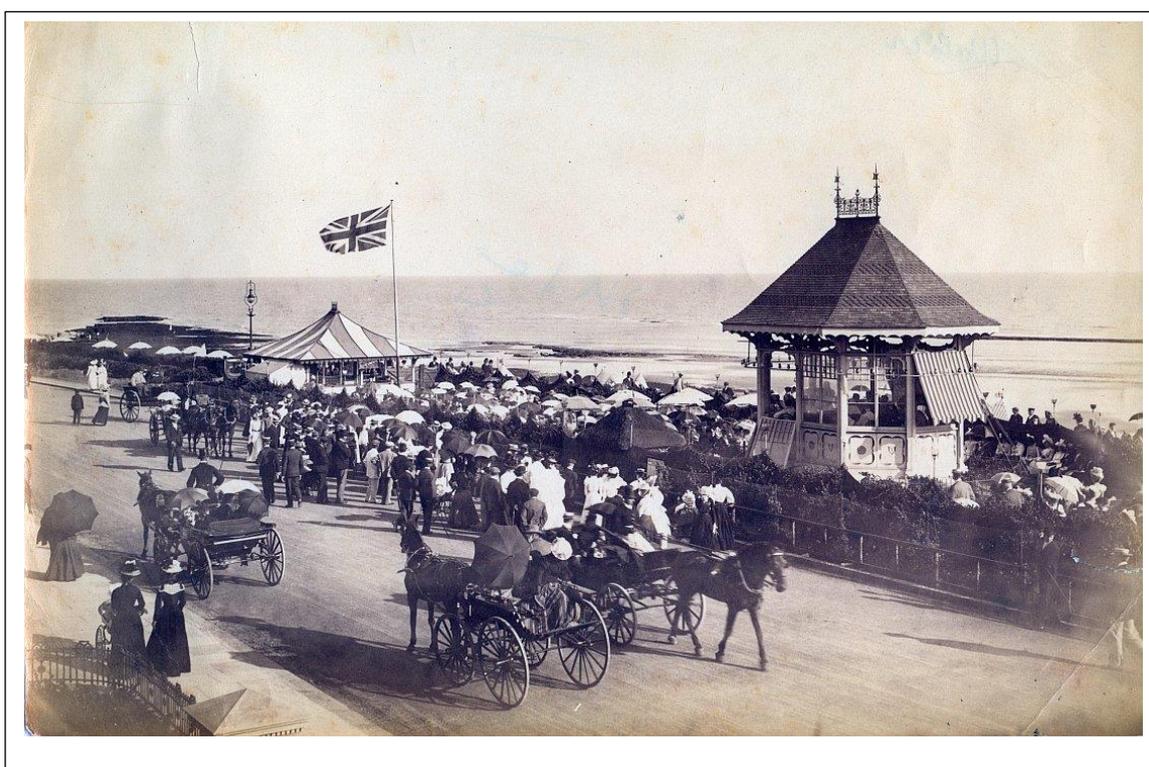
2. Bandstand from the north in 1895. Note removable window panels, flagpole and the audience position well below the level of the road and bandstand.

Photographic evidence (photo 2) shows that vertical exterior blinds were fixed to the top plate above the ventilation panels. We do not propose to reinstate these blinds.

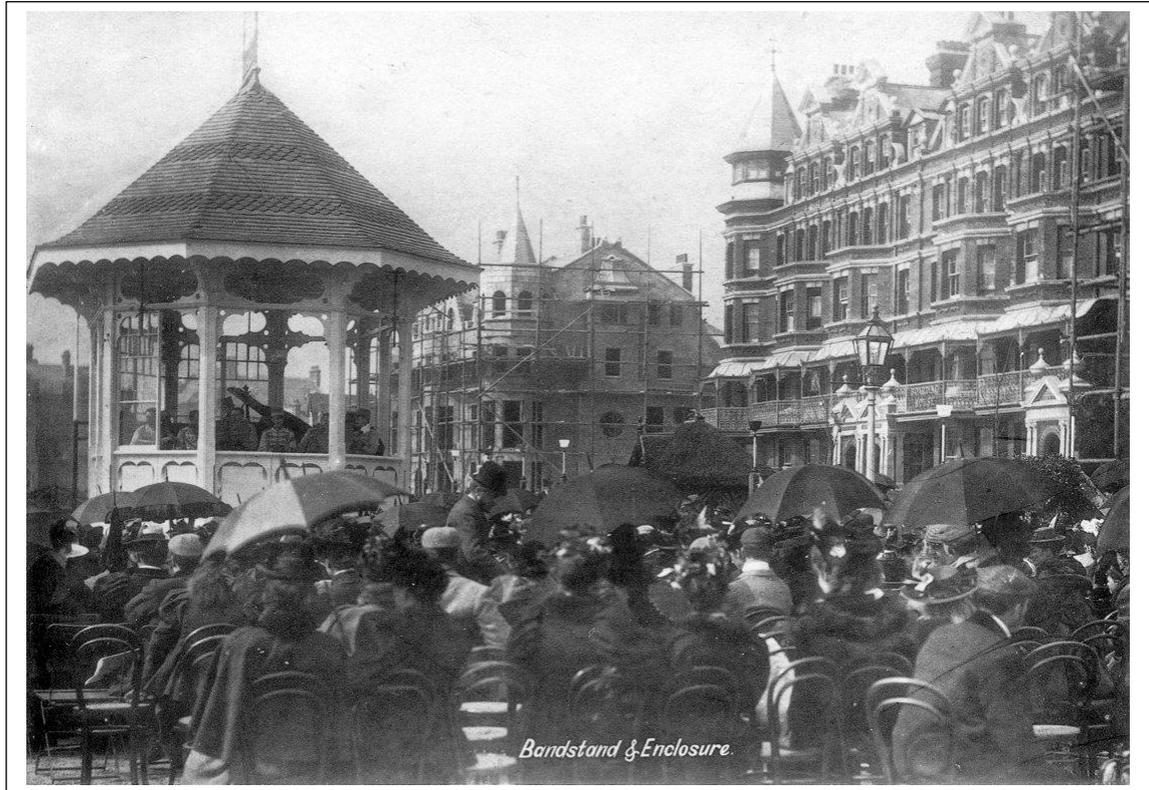
3. Bandstand from the East 1896. Notice the sunken enclosure for an audience, the removable window panels. Base panel plaques have been removed.

The bandstand's decorative base panels were a particularly distinctive feature of its original design. Photographic evidence shows a single piece of wood in Swan White framed by a decorative border also in Swan White with green highlighting to give a distinctive third dimension to the panels. A delicate rectangular board in Swan White was inserted within the frame. These rectangles each carried a painted coat of arms. These are indistinct on the photos 1 and 2, but we suspect that they were added to the bandstand in preparation for Queen Victoria's jubilee and then removed (photo 3).

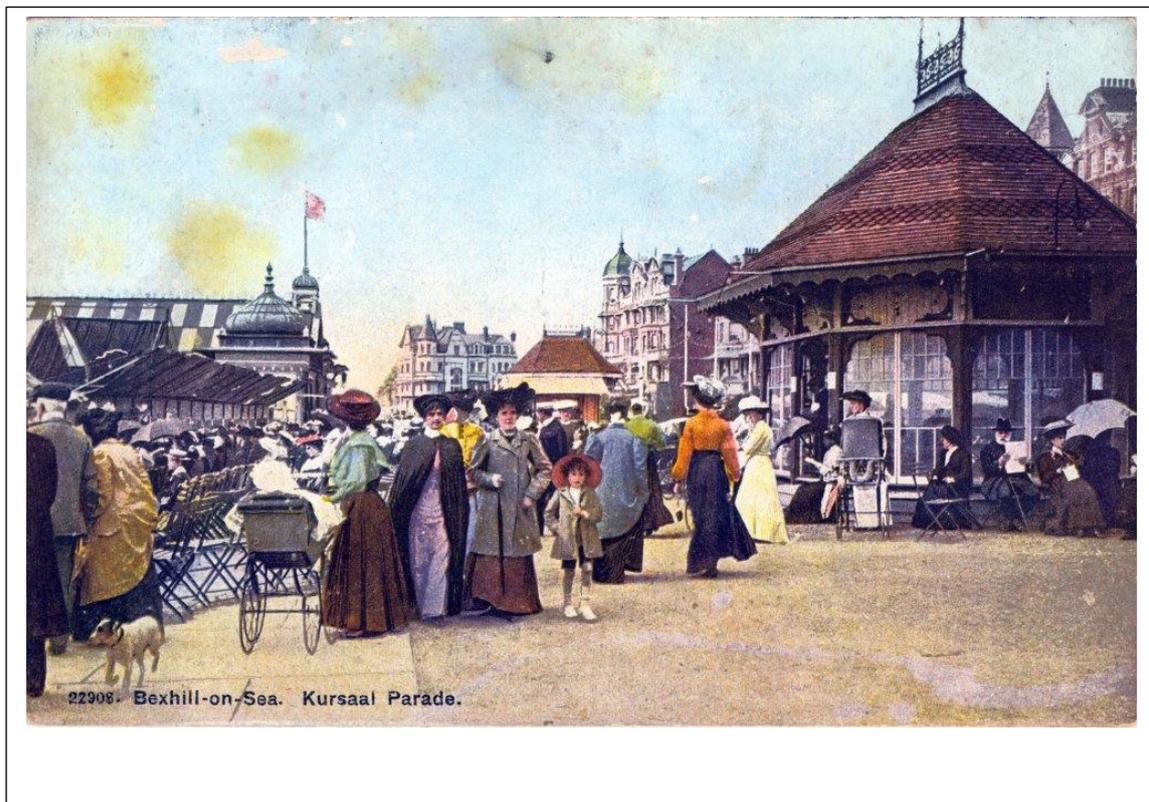
4. Bandstand following its conversion to a shelter. Note that window height is unchanged but base panel height is significantly reduced. The enclosure has been filled in.

The fence and lighting were removed when the bandstand was converted into a shelter in around 1906 (photos 4 and 5). The 'sunken' enclosure was raised to the level of the Kursaal Parade and one of the south-facing panels was removed to provide an entrance from the Parade (photo 4).

In 1906 the panels were removed and replaced with horizontal planking (photo 4) By 1910, window cills had been raised to reduce the height of the windows and allow for a higher base panelling (photo 5).

Conversion to a shelter around 1906 very significantly reduced the height of the base panels (from 900mm to 300mm) but left the height of the ventilation panels and windows unaltered (photo 4). Although there is some limited written evidence that Earl De La Warr had the shelter 'cut down', photographic evidence shows that raising the level of the surrounding land may have had a more significant part to play in altering the shelter's vertical proportions to a ratio of (5:14:3) (photos 4 and 5)

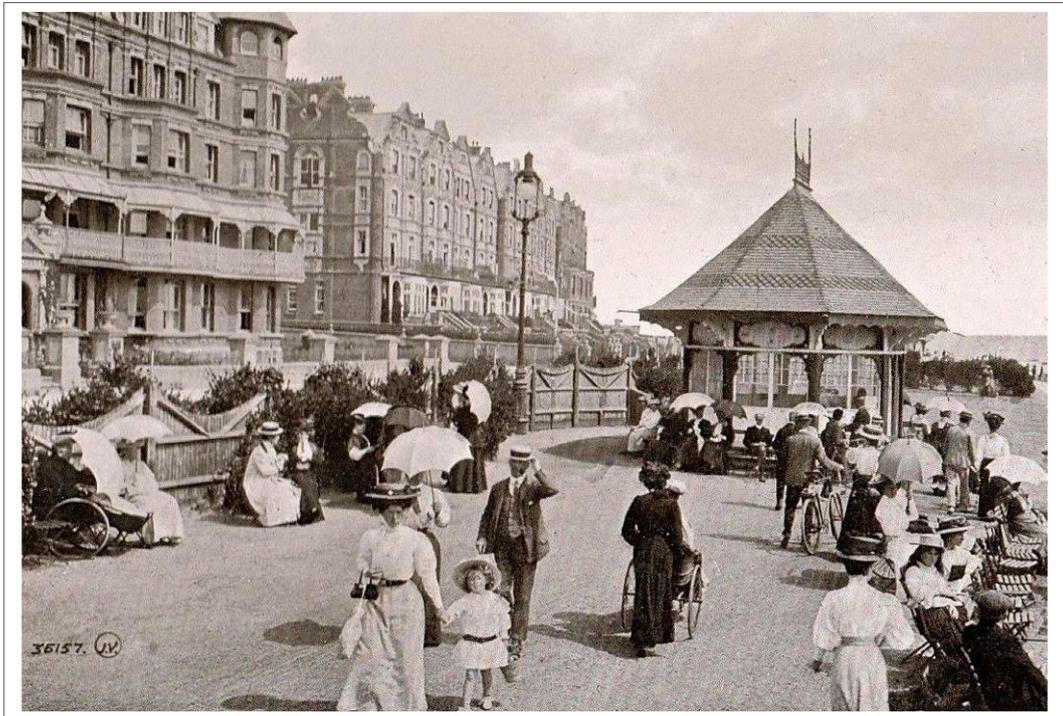
5. Shelter in 1910. Note reduced window height has been reduced and the base panel height has been increased. Notice ventilation panel detail.

Ten wooden ventilation panels were provided above each of the window panels. These remain in place and are of identical size and design to those featured in photographic evidence from the time (photo 5). They are likely to be original. Eight appear to be in good condition and the other two can be renovated. The panels are made of vertical tongue and groove planks painted in Swan White. They have lasted well in this less exposed and less vulnerable position. The thickness of the planks and their well-constructed frames have meant that the planks remain solid. There is minimal warping. The outer edge of each panel rests against a substantial decorative wooden frame painted in Signal Red. The frame has been shaped to match the cusps under the fascia boards and at the top of the window panels. Originally the wooden frames and panels were painted in Swan White. Four small holes in the shape of a cloverleaf have been cut into each panel to provide some degree of ventilation when the panels were in their closed position.

We are unsure when these proportions were further adjusted but assume that this will have taken place by 1910. A photograph from that time (photo 5) shows that the window cills will have been raised to reduce the height of the windows to 1170mm and to recreate a more recognisable base panel with a height of approximately 1000mm. The ventilation panel height was not changed. Arguably this restored some sense of verticality to the shelter by achieving a ratio of 5:12:10.
